The Impacts of Poor Drainage on Road Performance in Khartoum

Magdi M. E. Zumrawi

Department of Civil Engineering, Faculty of Engineering, University of Khartoum, Khartoum, Sudan

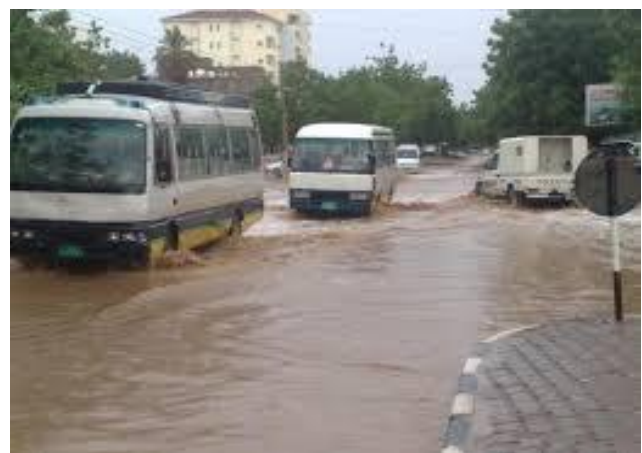
compliant from the residents in Khartoum and this problem becoming worse in this year. Poor existing drains and their improper operation and management mainly cause severe flooding which creates damages and problems to the road pavement and road users. As shown in Plate 1 a flooded road obstructed traffic flow.

Plate1.Flooded road obstructed traffic flow.

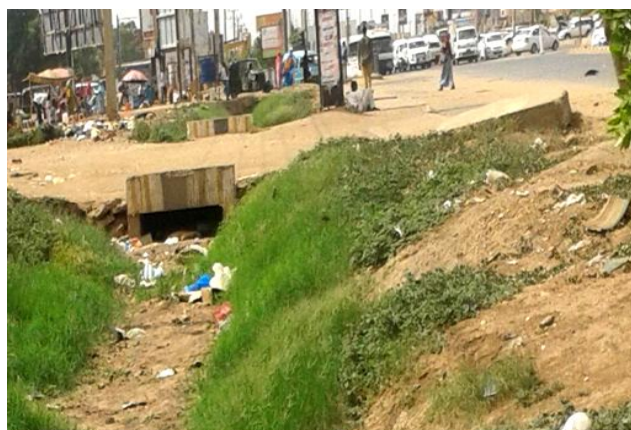
Plate 2.The side drain and the culverts were blocked with silt and sand accumulation, debris and vegetation.

Study. It was observed that the eastern carriageway of the road is connected with a side drain located far from the edge of the road at a distance about 5m to 8m. In general, most of the drain is open earth drain with small cross section of about 1m width and not more than 1m depth. The condition of the drain and its structures is very poor and getting deteriorated by the passage of time. The drain suffered from low capacity, natural siltation, absence of inlets, indefinite drainage outlets, lack of proper maintenance and over and above disposal of solid waste into the drain and the crossing culverts. The drain blocked with silt and sand accumulation, debris and vegetation as shown in Plate 2. It is clear that the drain and culverts being converted to a dumpsite and subsequently obstructed the water flow.

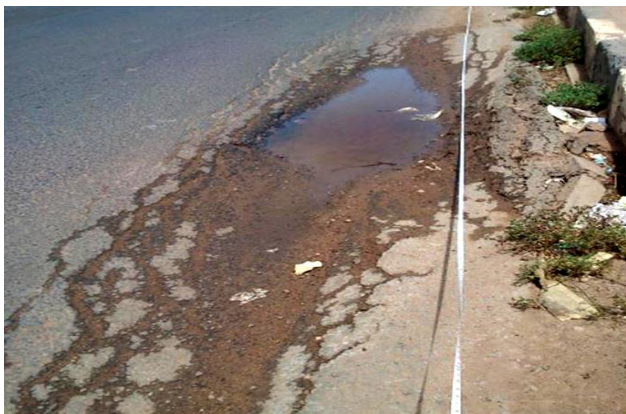
This bad condition of the side drain and its structures remains the same throughout the year causing the runoff water to flow on the surface of the road and unable to run off through the path far from the failed drain. The resultant effect of this critical situation causes serious distresses and damages on pavement. The road edges suffered from detachment of asphalt layer due to continuous contact of water leading to stripping of asphalt from aggregates resulting in severe pavement distresses of cracking, potholes and failure of edges as shown in Plate 3.

Plate 3. Severe pavement distresses of cracking, potholes and failure of edges.

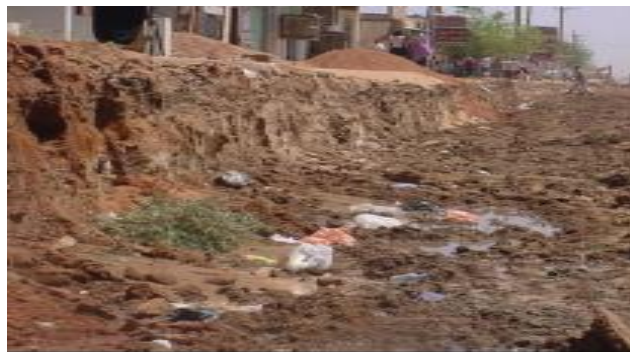
During excavation work, it was observed that the subgrade soil was fully saturated with subsurface water encountered at 2m depth. As seen in Plate 4. accumulation of sewage water disposed from neighbor houses into the subsoil.

Plate 4. Accumulation of subsurface water on the sub grade of expansive soil.

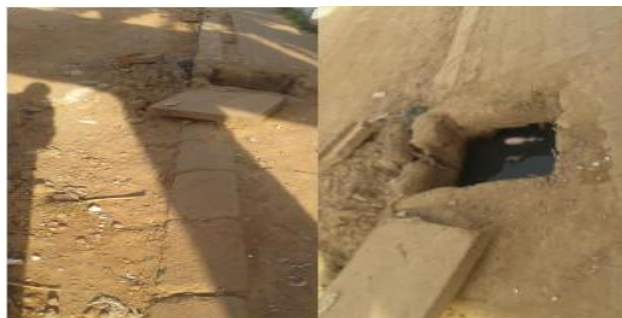
In the field survey, it was observed that the side drain was full with dirty water and refuse dumps. The inlets on the curb was blocked with soil accumulation as shown in Plate 5.

Plate 5.The side drain full with dirty water and refuse dumps.

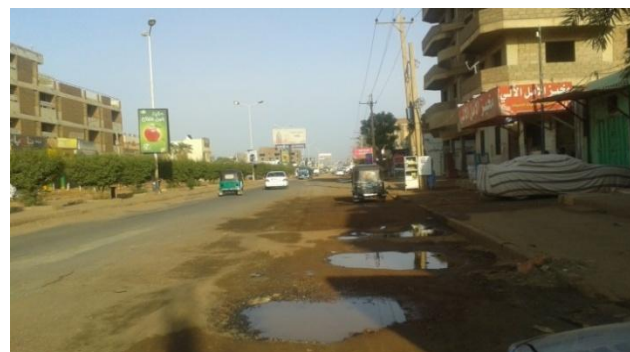
Failures and severe distresses were observed on the road surface. It was found that the surface runoff water penetrated through the cracks and potholes cause a progressive inward penetration of the zone of soil movement leading to soil expansion and ultimately failure of the pavement. Therefore, the major cause of pavement deterioration is inadequate drainage. Significant cracking, potholes, heavy depression and edge failure as shown in Plate 6 and 7.

Plate 6.Severe failures of road edges due to water ponding on surface.

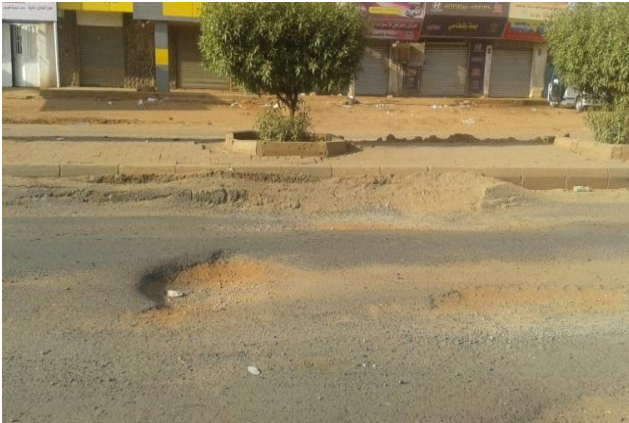
Plate 7.Sever failure of edgesand potholes.
