Damages of Buildings on Expansive Soils: Diagnosis and Avoidance

Magdi M. E. Zumrawi¹, Asim O. Abdelmarouf², and Abubakr E. A. Gameil³

Abstract

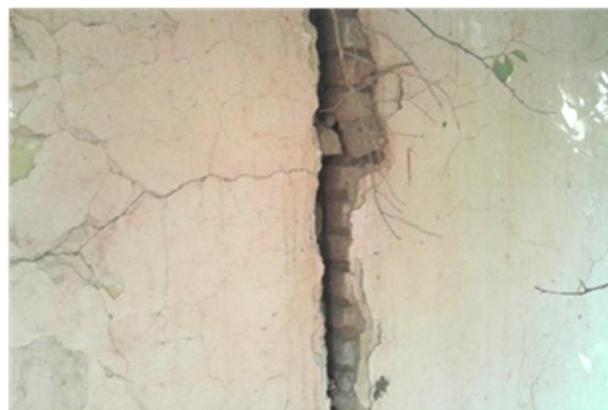
The most common exterior damage was to the fence walls. Most of the surveyed houses, the fence walls are supported on strip foundation at a shallow depth. It was clearly observed that the walls nearby gardens are much suffered serious cracks due to the adverse effect of garden watering, shown in Figures 3 and 4. Cracks were vertical, horizontal or diagonal, and almost always through the mortar joints between bricks. Cracking were from hairline to more than 20 mm in width. In some cases the whole wall was separated, as shown in Figure 4.

Figure 4 Severe and deep cracks appear in the exterior walls of the building

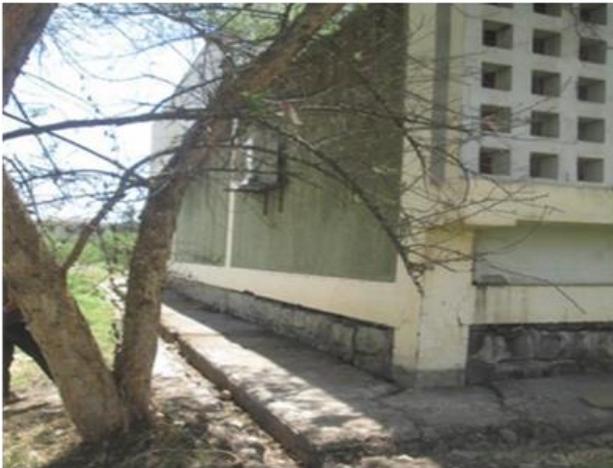
The roots of big trees grown adjacent to the building resulted in settlement of the foundation wall around the corner of the building as shown in Figure 5. Also severe

Figure 5 Foundation wall partially settled around the corner due to trees nearby the building

Existence of lawns and gardens with fast growing trees in the vicinity of the building may cause cracks in walls due to expansive action of roots growing under the foundation. Roots of some trees generally spread horizontally on all sides in the effective zone of the foundation soil when trees are located close to a building, [19].

Trees absorb water from the nearby foundation soil through their root system and cause shrinkage of soil especially during the dry season when moisture available for roots to suck is the least. This is the reason why big trees should not be located within a distance of 0.5 to 1 times their mature height from the structure. To minimize the effect of big trees roots, moisture barriers should be put in place to cover the effective zone of foundation soil, [19].

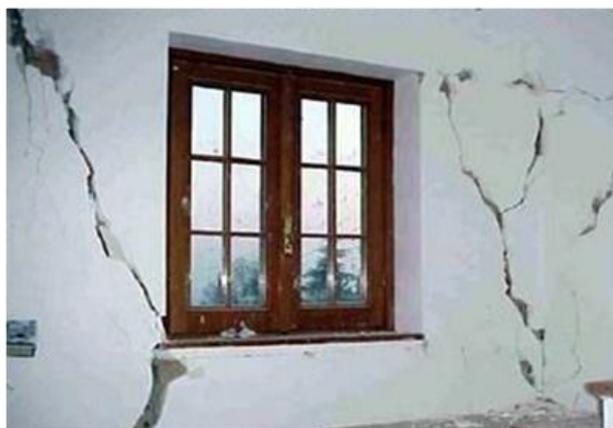
The building internal walls as well as floors much suffered from serious cracks. It was observed that the cracks are generally diagonal at approximately 45° occurred above and below windows and above doorways. Movement of the walls had distorted door and window frames. The major type of damage observed in the houses is severe cracks around corners of doors and windows and reduction in wall height due to sinking of foundation. However; the extent of damage in the internal walls ranges from minor to severe cracks in different direction as shown in Figure 6.

Figure 6 Serious cracks around window in the interior wall

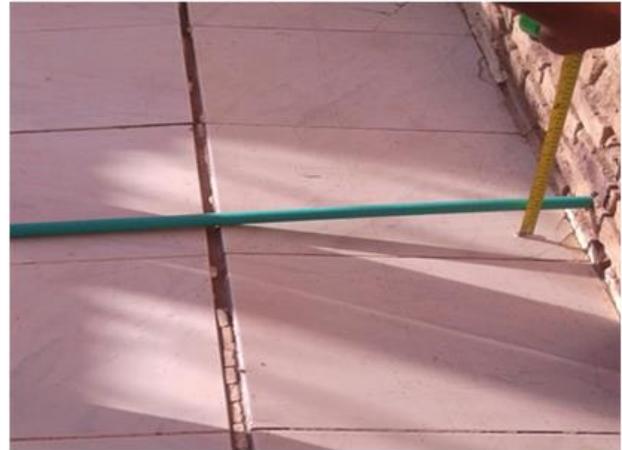
Floor damage caused by expansive soils is evident in most houses, shown in Figures 7 and 8. In these figures, it was observed that floor heave caused uneven level of the ceramic tiles and serious cracks appear on the slab. The floor heave resulted in difficulty in opening doors and windows as clearly seen in Figure 9.

Figure 7 Floor heave resulted in considerable difference in level about 5.5 cm

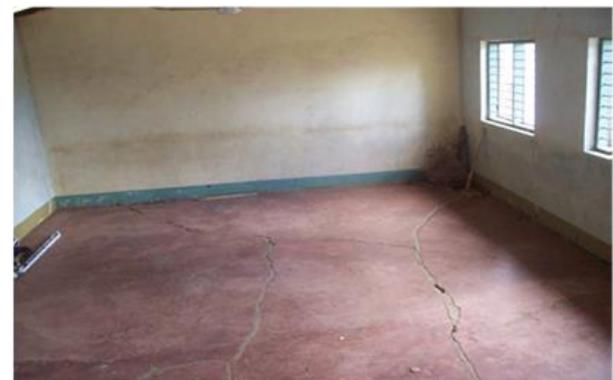
Figure 8 Heaving of interior floor causing cracking of slab

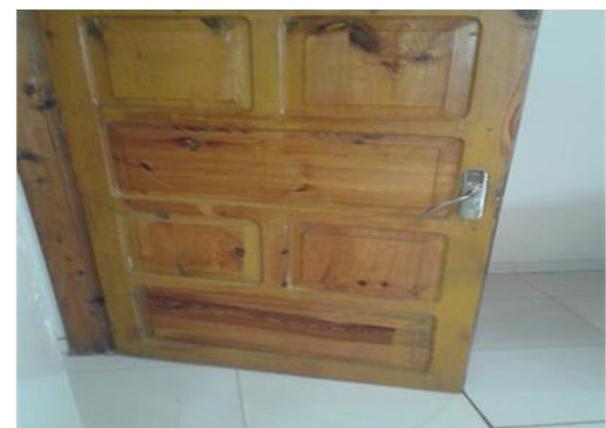
Figure 9 Doors not properly close or open due to movement of floor

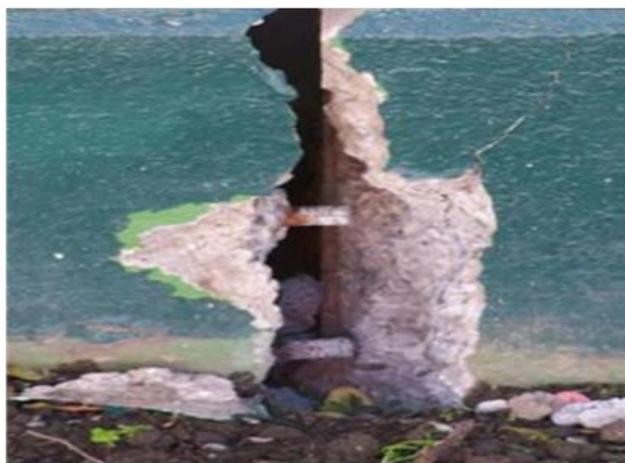
Damage to concrete perimeter foundations caused by differential heave of the foundation soil ranged from minor hairline and 1 to 2mm cracking to much larger cracks with anywhere from 50-100 mm of separation and significant lateral offsets, as shown in Figure 10.

Figure 10 Severe cracking in concrete perimeter wall showing exposed reinforcing
